BEATING THE CLOCK

THEY HAD LESS THAN FIVE DAYS TO REMOVE, REFINISH, REINSTALL AND RESTART A HEADBOX – WHILE ANOTHER TEAM WAS SIMULTANEOUSLY WORKING ON THE UNIT.

BUT WITH METICULOUS PLANNING AND PRECISE COORDINATION, BOWATER THUNDER BAY AND GL&V MET THE CHALLENGE – AND BEAT THE CLOCK.

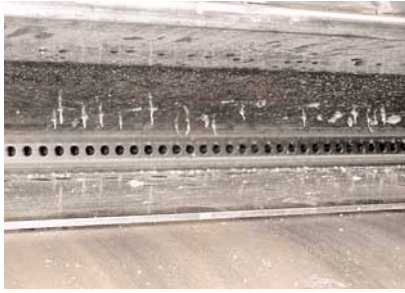
For years, the polished stainless steel surfaces on the headbox slice body and apron had been exposed to the abrasive and corrosive fillers needed to create a high quality sheet. As a result, these once-pristine surfaces had become covered with scores of scratches and pits. Fibers and other organic matter lodged in these surface flaws, forming into "stringers". When these stringers eventually broke off, they fell into the stock and onto the sheet and four-drainer wire. The result was roll after roll of blemished, lower quality sheet. According to Dean McDonald, Paper Machine Superintendent for Machine No. 4,

There is only one certain solution to stringers: a process known as headbox polishing, where the surfaces are meticulously ground and sanded to precisely remove the pitted layer of stainless steel, leaving a clean, smooth and unblemished surface behind. According to GL&V's Stéphane St-Cyr, headbox polishing is a job that requires exacting skill and patience. "You can't rush it. You have to proceed gradually to make certain you remove all the pits and scratches – without leaving new scratches behind." All in all, over 225 square feet of surface would have to be polished, with every inch finished to a mirror-like 4 RMS to meet specs.

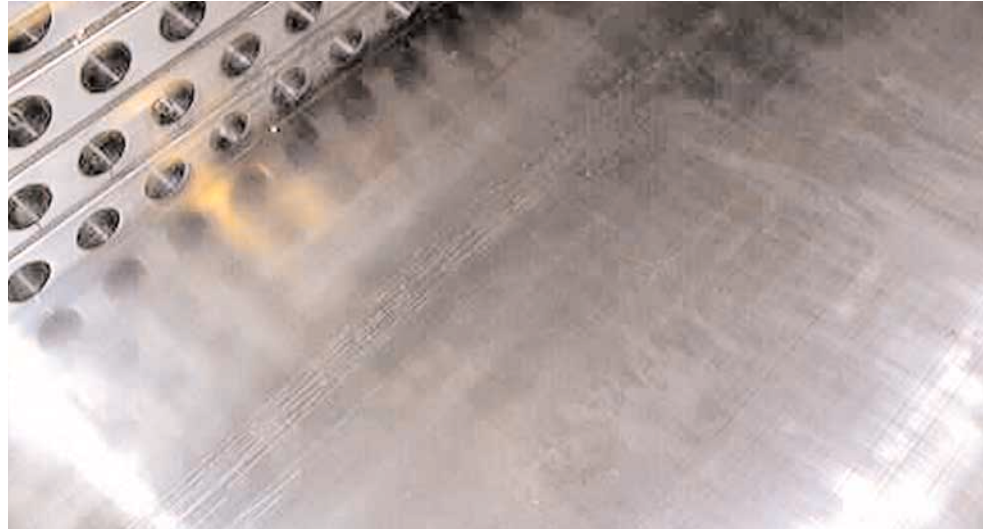
To get to the scarred surfaces, the headbox would have to be removed from Machine No. 4, placed in a specially fabricated cradle and partially dismantled. Obviously, this series of operations could only be accomplished during a complete machine shutdown. And the polishing process itself would take days to

By 8 AM on the 14th, the headbox was in position in its cradle and disassembled. Now, the project could begin in earnest. Working around the clock in twelve-hour shifts, each team of six workers carefully polished the stainless steel surfaces. It was a labor- and time-consuming process, as the polishers gradually moved from medium to fine abrasives in order to produce a fine, scratch-free finish. While the team installing the slice actuator upgrades, worked on one side of the headbox, the GL&V team worked on the other. "Fortunately, it was a big enough headbox for the both of us," jokes St-Cyr.

For three straight days and six consecutive twelve-hour shifts, the work went on inside the headbox. In addition to polishing out the stainless steel surfaces, the GL&V teams also made other repairs to the surfaces, filling in cracks and repairing the outside edge of the apron lip. The last step in the polishing process was passivating, where the freshly polished stainless steel surfaces were treated with a solution of nitric and sulfuric acid to create a
