SOMETHING OLD, SOMETHING NEW

HOW CASCADES AND GL&V
REBUILT AN AGING DRYER SECTION
INTO A HIGH PERFORMANCE
DRYING SYSTEM.

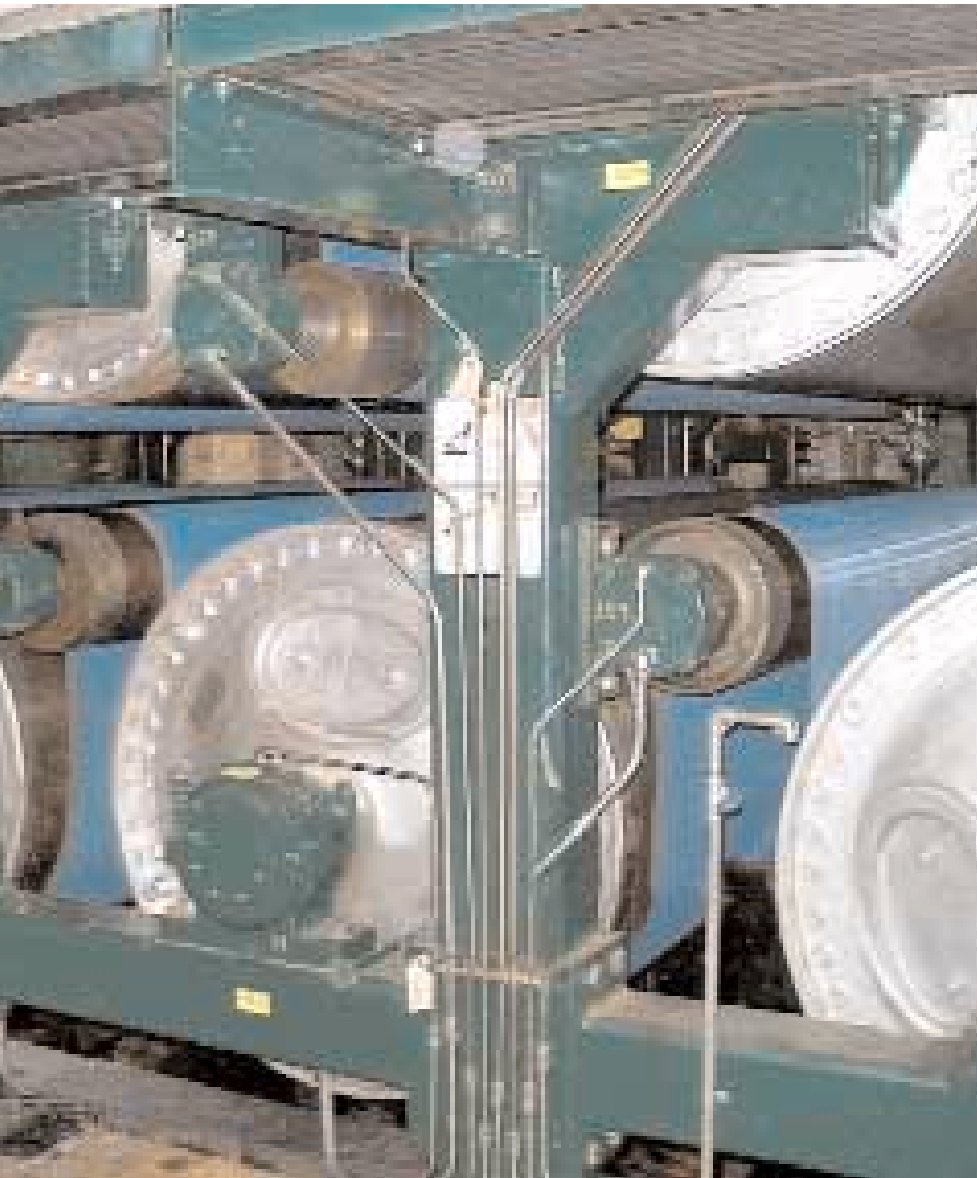
Dryers prior to reconditioning.

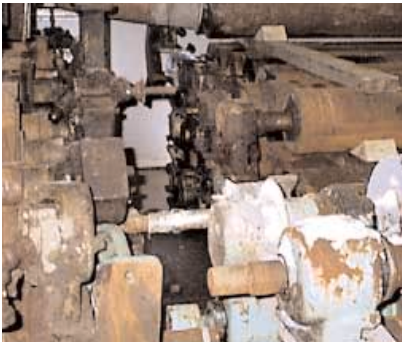
Felt rolls prior to reconditioning.

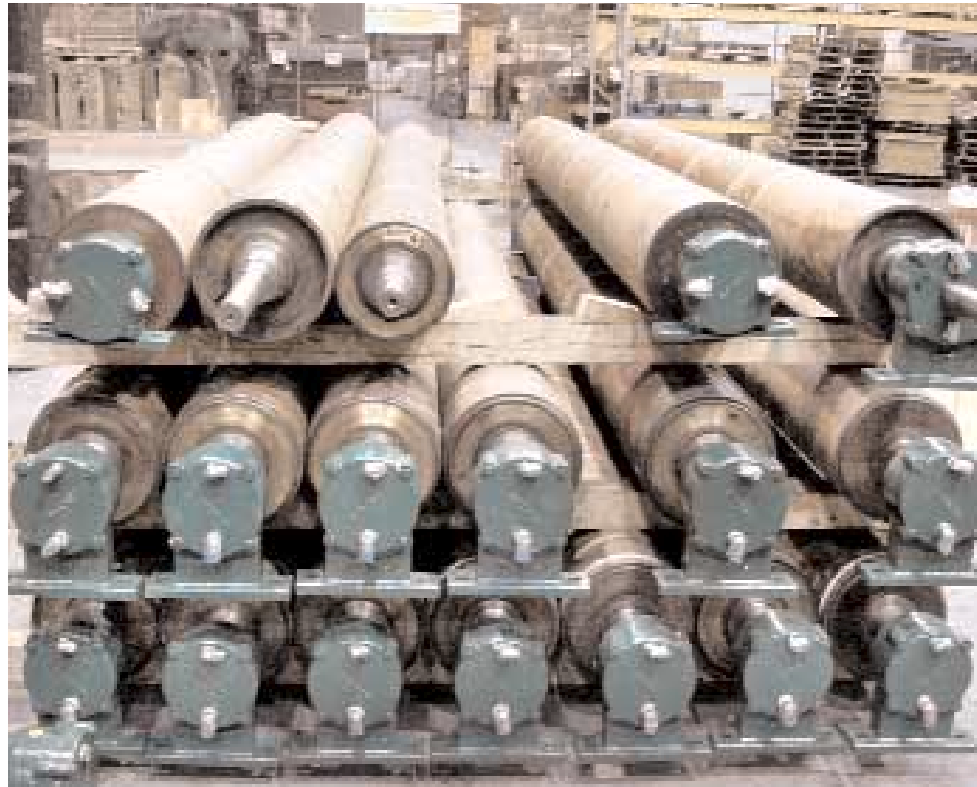
Felt rolls after reconditioning.

GL&V's first contribution to the project was to inspect, disassemble and overhaul the used dryer cylinders and related equipment. This was all done in the field or at their 100,000 sq. ft. facility in Hudson Falls, NY. While this was underway, GL&V's engineers were designing a new box steel dryer frame to accommodate the newer, faster, wider equipment. After the new frame was fabricated in-house, the entire dryer section – including all the cans and dryer felt rolls, bearing housings, piping, sole plates, motor stands, walkways and rope tail threading system – was assembled and tested at the GL&V facility. By

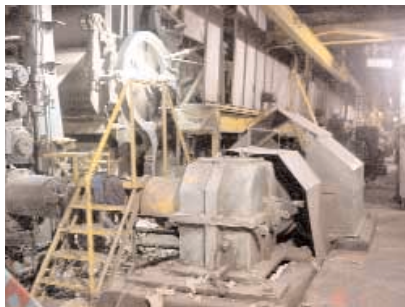
Original line shaft drive.

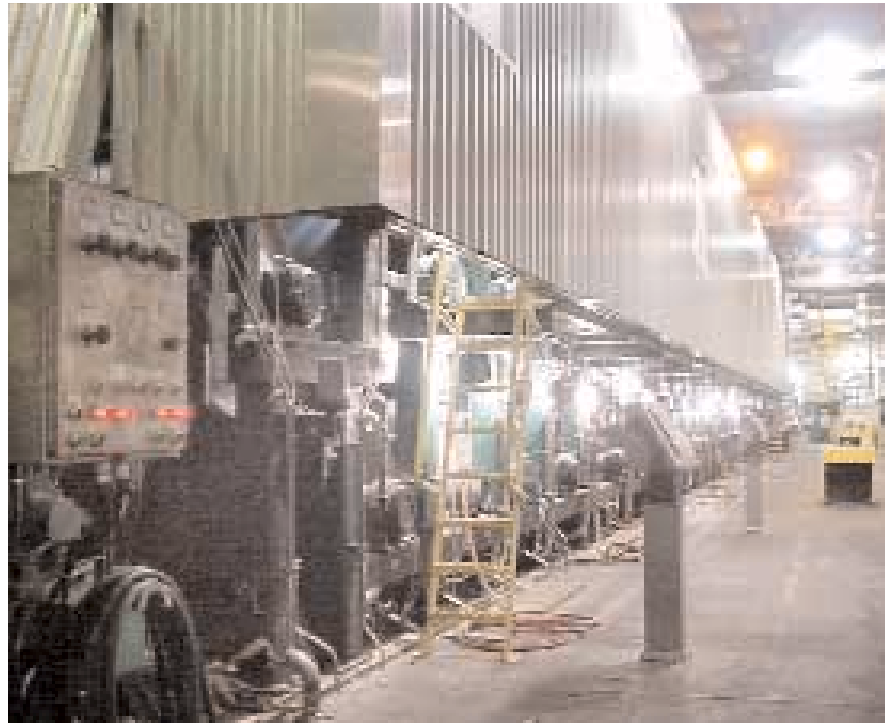
Tending side of the dryer section.

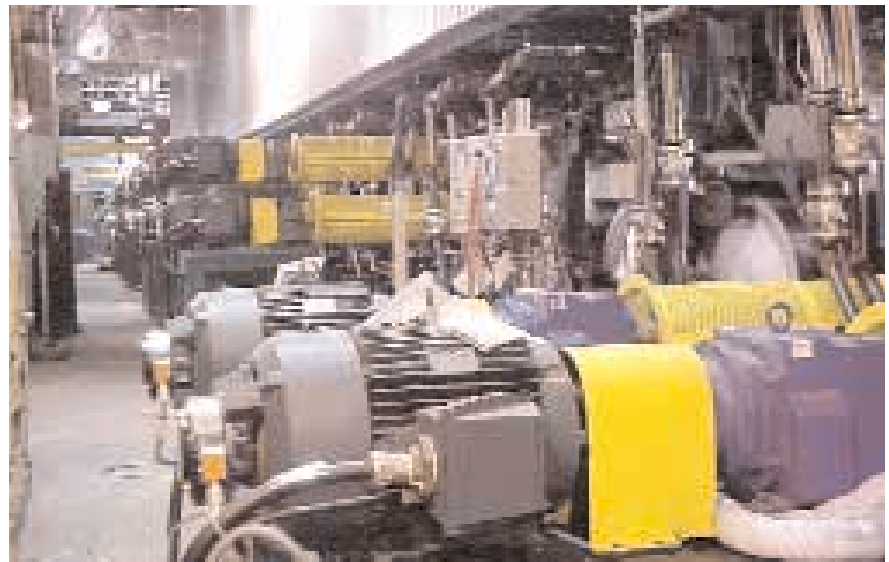
Drive side of the dryer section.
